# **INDOOR AIR QUALITY ASSESSMENT**

**Riverbend Elementary School  
Athol-Royalston Regional School District  
174 Riverbend Street  
Athol, Massachusetts**

Prepared by:  
Massachusetts Department of Public Health  
Bureau of Environmental Health Assessment  
Emergency Response/Indoor Air Quality Program  
August 2003

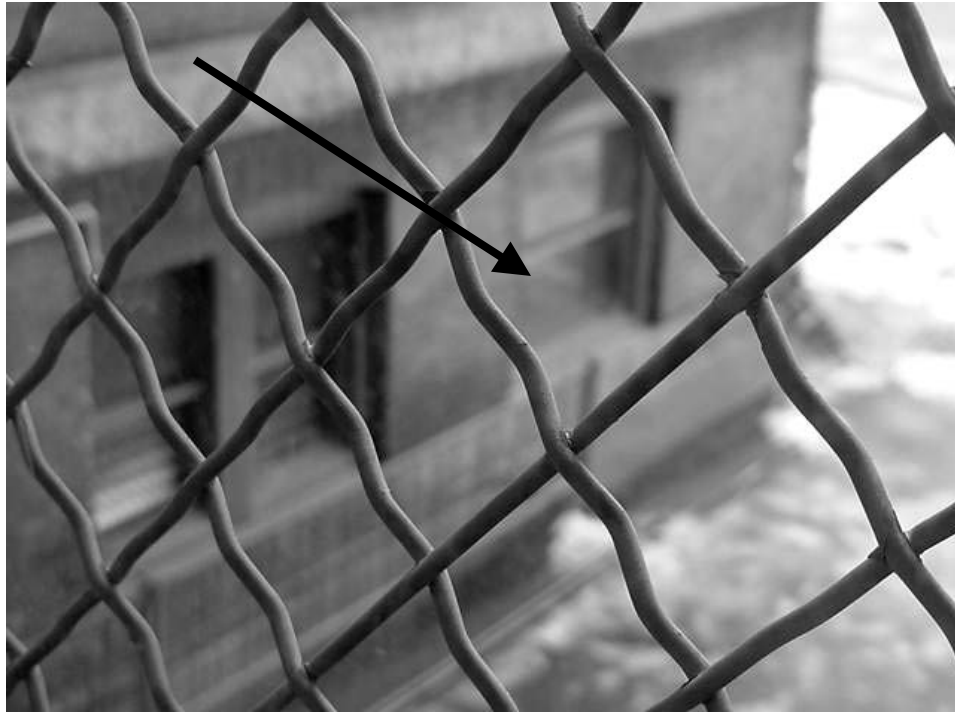
**Picture 1**

Two forms of mechanical ventilation systems exist in the building. Mechanical ventilation in the 1906 wing was originally provided by an air-handling unit (AHU) located in a room on the ground floor. Fresh air is drawn into the building through a louvered vent in the basement (see Picture 1). Air is drawn through heating elements into a fan unit that distributes the air via wall mounted fresh air grilles in classrooms. Classroom fresh air supply grilles (see Picture 2) are connected to the fan unit by ductwork. The ventilation system appears to have been abandoned as part of an energy conservation project based on the following observations:

- The fan belt connected to the motor that drives the fan unit was removed (see Picture 3).
- Energy efficient windows were installed over fresh air intake vents (see Picture 1).
- The system may have also been abandoned due to the presence of pipes insulated with asbestos-containing materials. The pipe wrap appeared to be intact and was well labeled.

**Original Fresh Air Intake Sealed by Energy Efficient Windows**

2. Examine the feasibility of restoring the original ventilation system in the basement. This restoration may include removal of asbestos insulation from pipes inside the fan room.

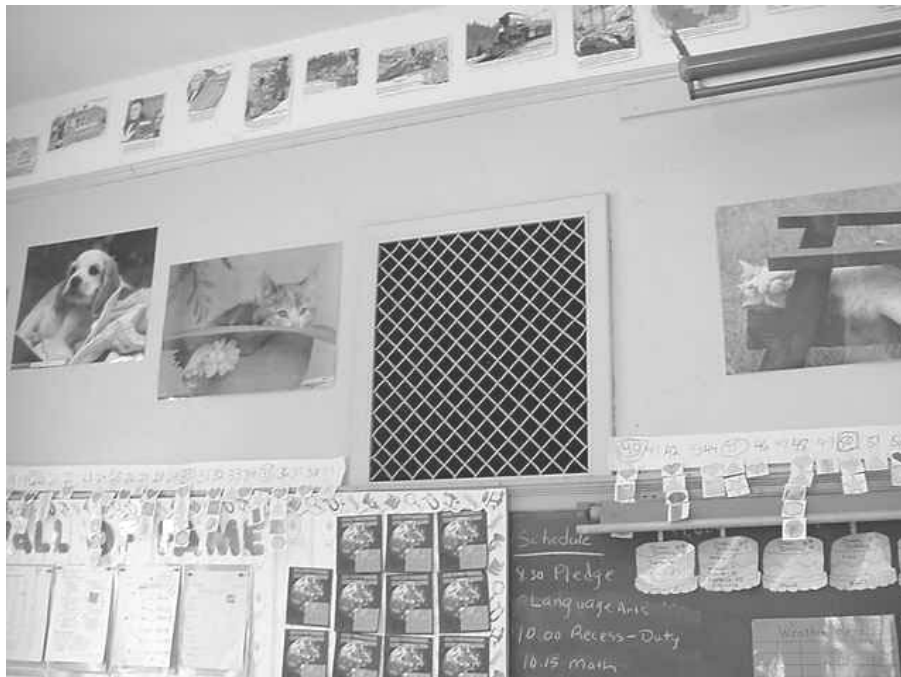
**Picture 2**

**Fresh Air Supply Vent 1906 wing**

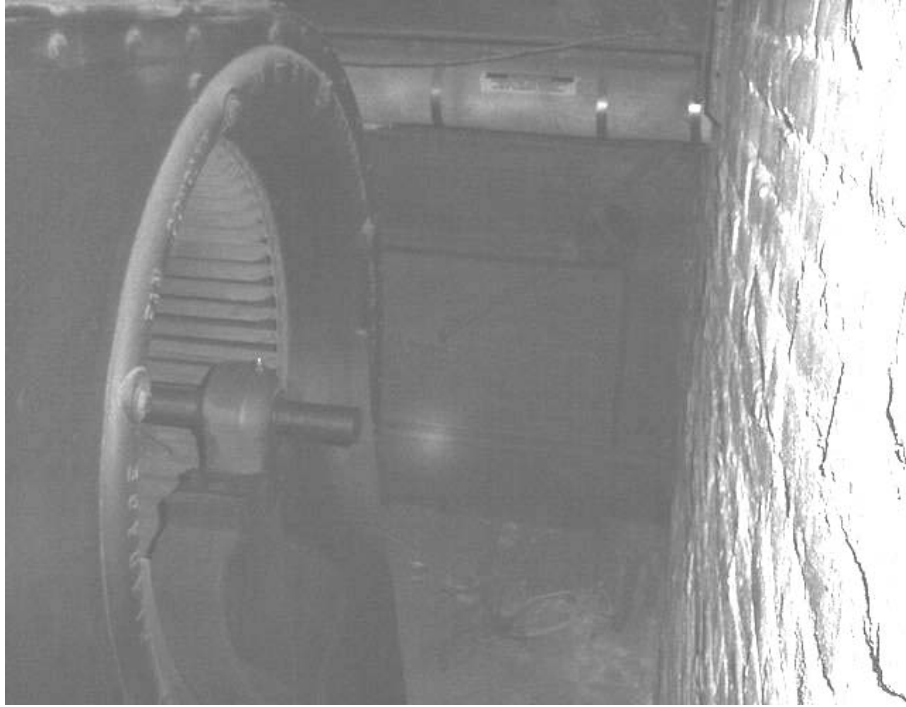
**Picture 3**

**Deactivated Fresh Air Supply Fan in Room Adjacent to Boiler Room, Note Fan Belt is Removed**

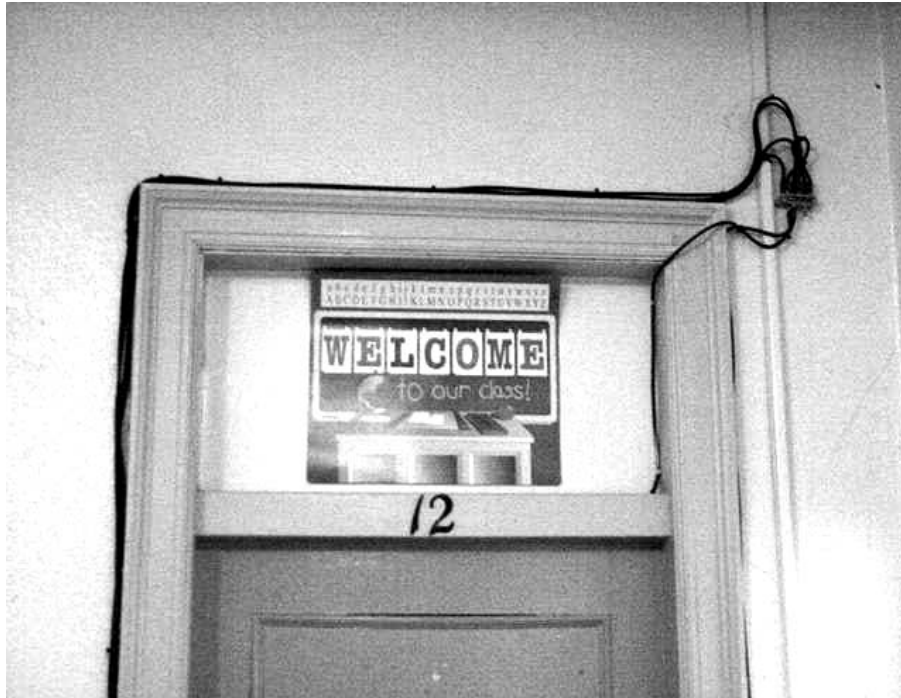
**Picture 4**

During summer months, ventilation within the 1906 section is controlled by the use of openable windows in classrooms. This section was originally configured in a manner to use cross-ventilation to provide comfort for building occupants. The building is equipped with windows on opposing exterior walls. In addition, the building has hinged windows located above the hallway doors. This hinged window (called a transom)(see Picture 4) enables occupants to close the hallway door while maintaining a pathway for airflow. This design allows for airflow to enter an open window, pass through a classroom, through the open transom, enter the hallway, pass through the opposing open classroom transom, into the opposing classroom and exit the building on the leeward side (opposite the windward side) (see Figure 1). With all windows and transoms open, airflow can be maintained in a building regardless of the direction of the wind. This system fails if the windows or transoms are closed (see Figure 2). Each classroom would have a long pole with a hook that was used to open the hoop latch that locks the transom. All of the transoms in the 1906 building have been permanently sealed.

**Transom over Classroom Door**

pattern of the building. To aid cross ventilation, open hallway doors in areas with inoperable transoms.

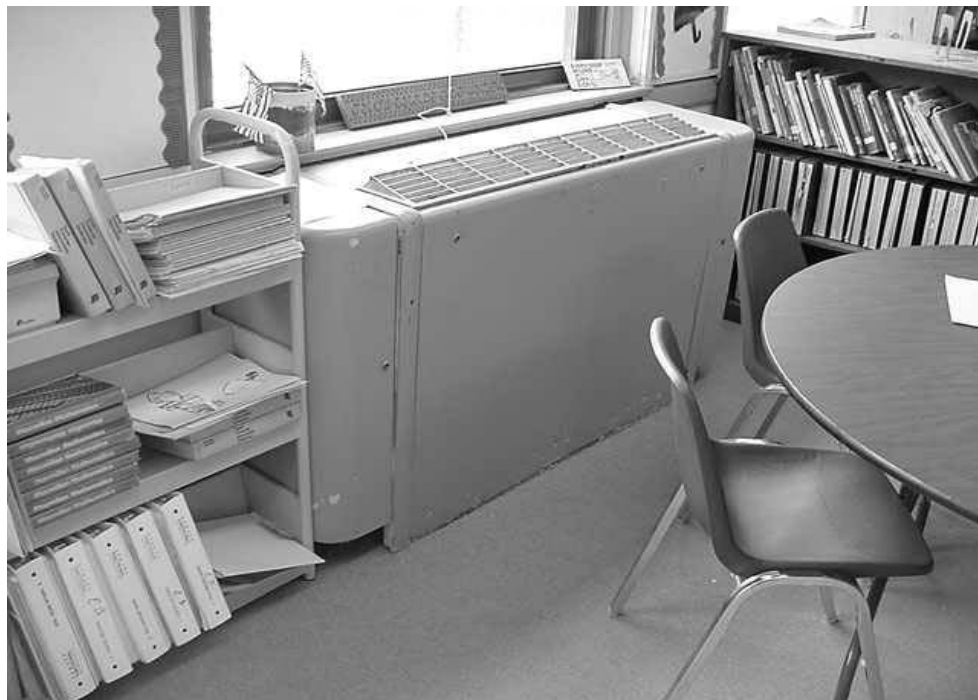
**Picture 5**

The 1950's section has fresh air supplied by a unit ventilator (univent) system (see Picture 5). Within each univent is a fan. Opposite this fan is a set of moveable louvers through which fresh air enters the univent. Univents are designed to draw air from outdoors through a fresh air intake located on the exterior wall of the building and return air through an air intake located at the base of each unit (see [Figure 3](#)). Fresh and return air are mixed, filtered, heated and provided to classrooms through a fresh air diffuser located on the front of the unit.

**Typical Classroom Univent**

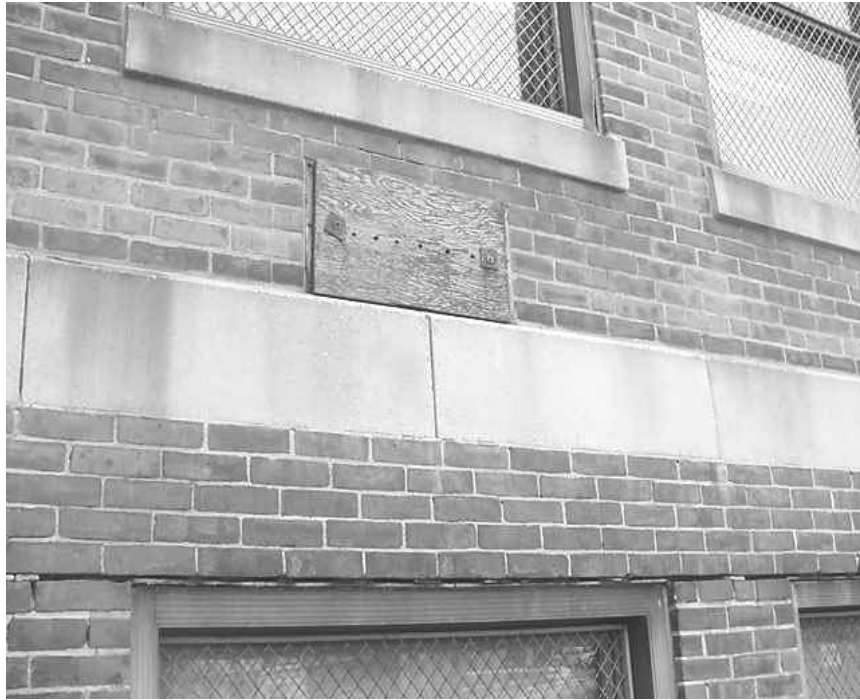
**Picture 6**

Univents were found deactivated, which prevents a continuous source of outside air to provide ventilation. In addition, the fresh air intakes were sealed with plywood (see Picture 6). In order for univents to function as designed, univent fresh air diffusers and return vents must be unblocked and remain free of obstructions. Importantly, these units must be activated and allowed to operate.

**Univent Fresh Air Intake Sealed with Plywood**

1. Consult a ventilation engineer to determine whether the building can be retrofitted with a modern mechanical ventilation system.
2. Survey 1950s classrooms for univent function to ascertain if an adequate air supply exists for each room and make univent repairs as needed. Consider consulting a heating, ventilation and air conditioning (HVAC) engineer concerning the restoration and calibration of univent fresh air control dampers.

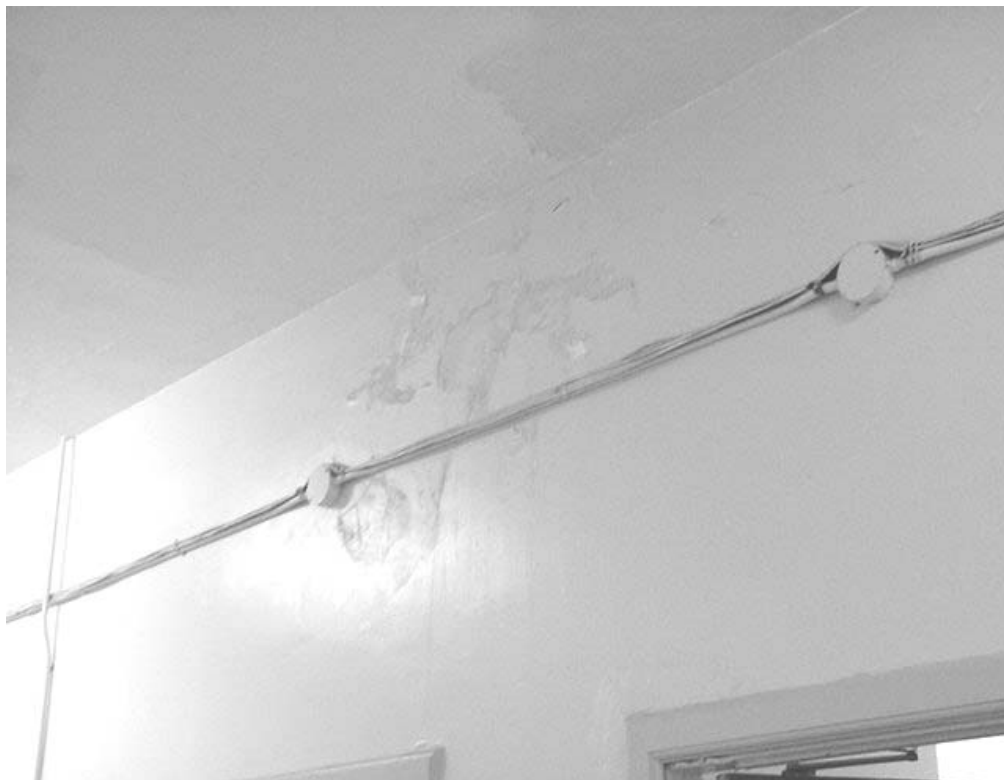
**Picture 7**

Several areas show signs of historic water damage to wall plaster from roof leaks (see Picture 7) and steam pipe leaks (see Picture 8). Wall plaster is not a good mold growth media, however, water trapped behind wallpaper or paint can become a vehicle for mold growth.

**Historic Plaster Damage from Roof Leak**

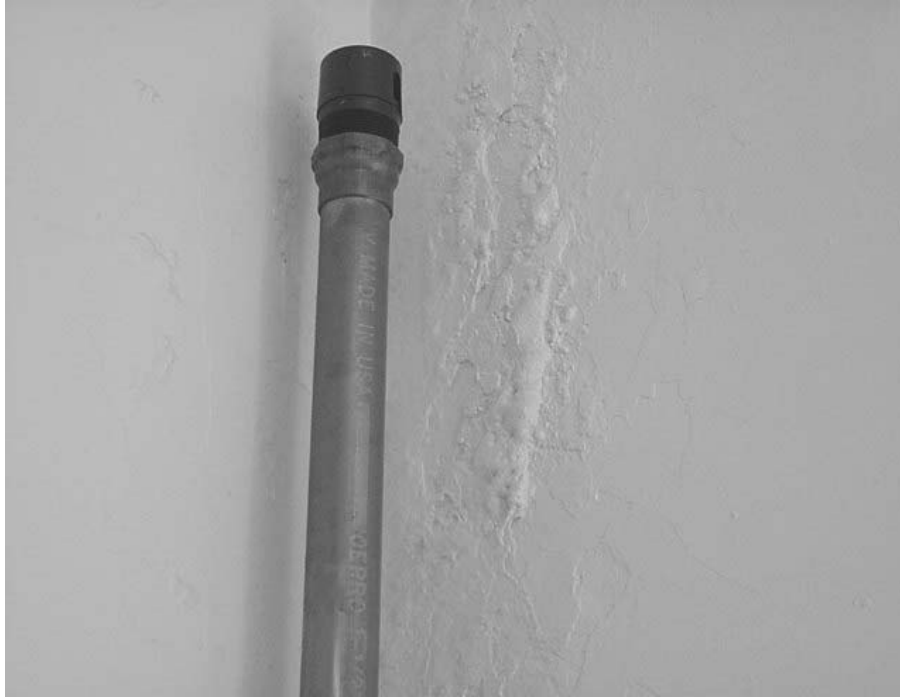
**Picture 8**

**Plaster Damage from Heating System Steam**

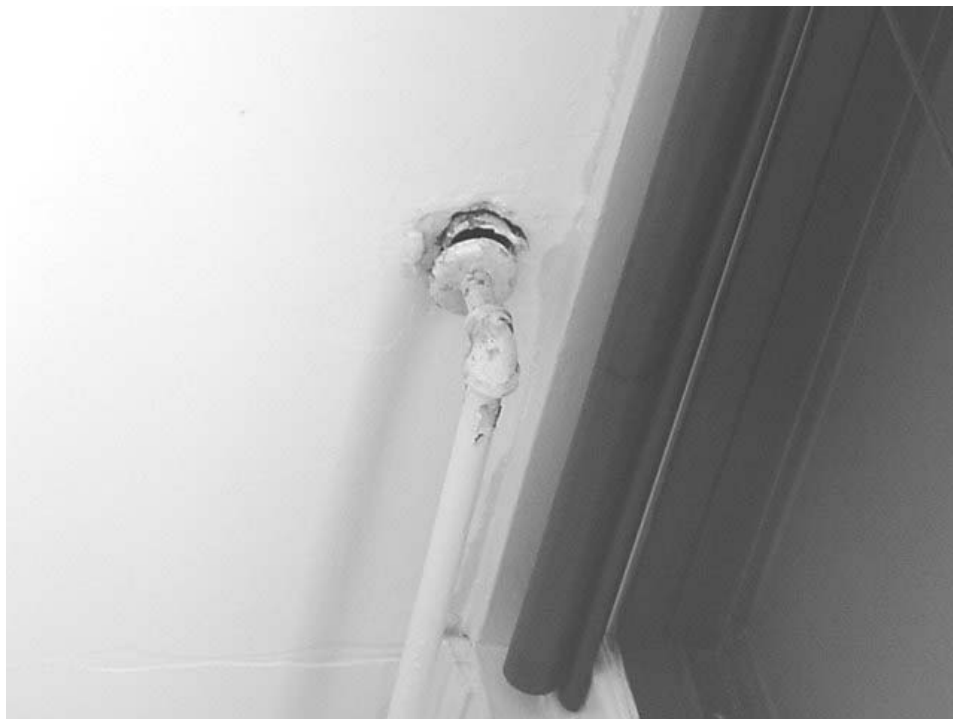
**Picture 9**

Several other conditions were noted during the assessment, which can affect indoor air quality. The abandoned ventilation system can serve as a pathway for basement particulates and odors to migrate into occupied areas of the building. Holes in walls and ceilings may also serve as pathways for particulates (see Picture 9). In general, cold air migrates to areas with heated air, thereby creating drafts. The temperature in the heating coil room will generally be lower than the occupied areas of classrooms, therefore colder basement air will move to classrooms via the vent system if means of access (holes, open access doors) exist in the ductwork.

**Utility Hole in Ceiling for Pipes**

7. Replace missing ceiling tiles and fill utility holes in classrooms (e.g. around radiator pipes), to prevent the egress of odors, dust and particulate matter between areas.

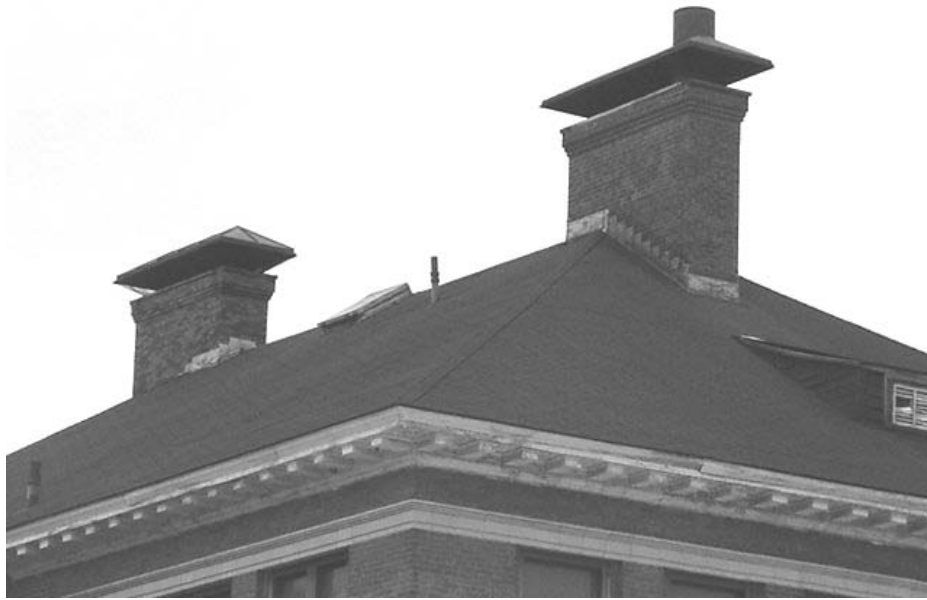
**Picture 10**

The exhaust system ventilation shafts (see Picture 10) do not appear to have bird screens. In addition, an attic vent appears to be damaged in a manner to allow for pest entry (see Picture 11). Bird and bat wastes are associated with molds (*Histoplasma capsulatum*) (CDC, 2001; NIOSH, 1997) and are of concern for immune compromised individuals. To prevent roosting of birds and bats in these areas, entryways should be secured with bird screens.

**Exhaust Vents without Bird Screens**

5. Install bird screens on roof top airshafts. Repair damage vent grill in attic (see Picture 11).
6. Consider discontinuing the use of tennis balls on chairs to prevent latex dust generation.

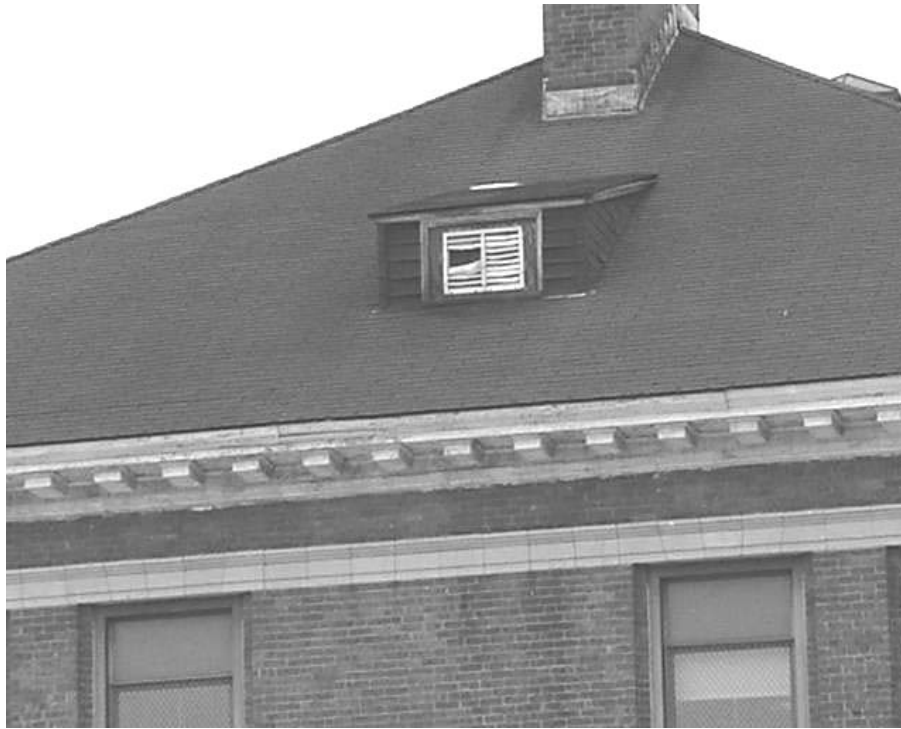
**Picture 11**

**Damaged Vent under Attic Window**
